Appendix D

Site Photos

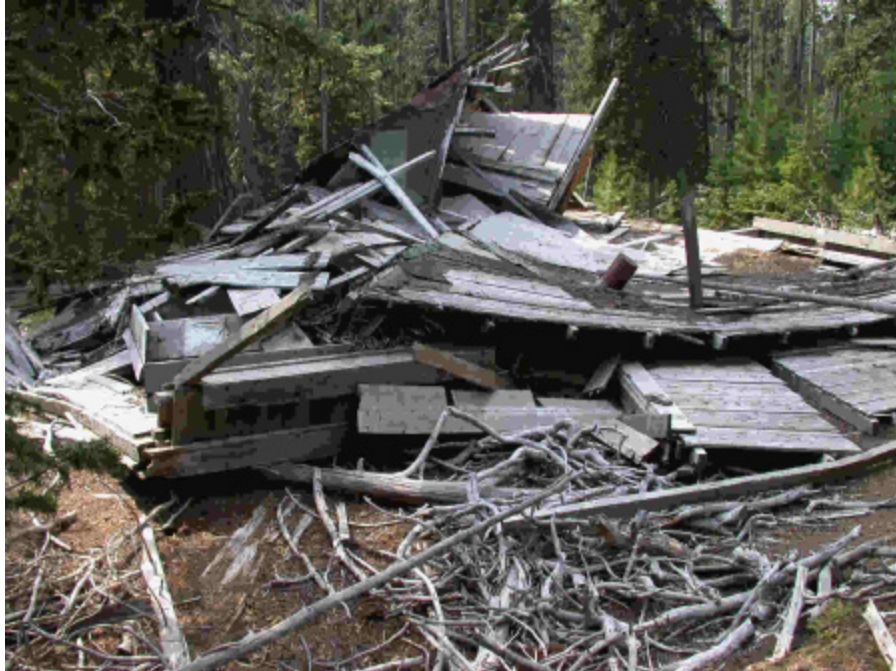
Photo 1. Collapsed residence building. (Photo by D. Boles)

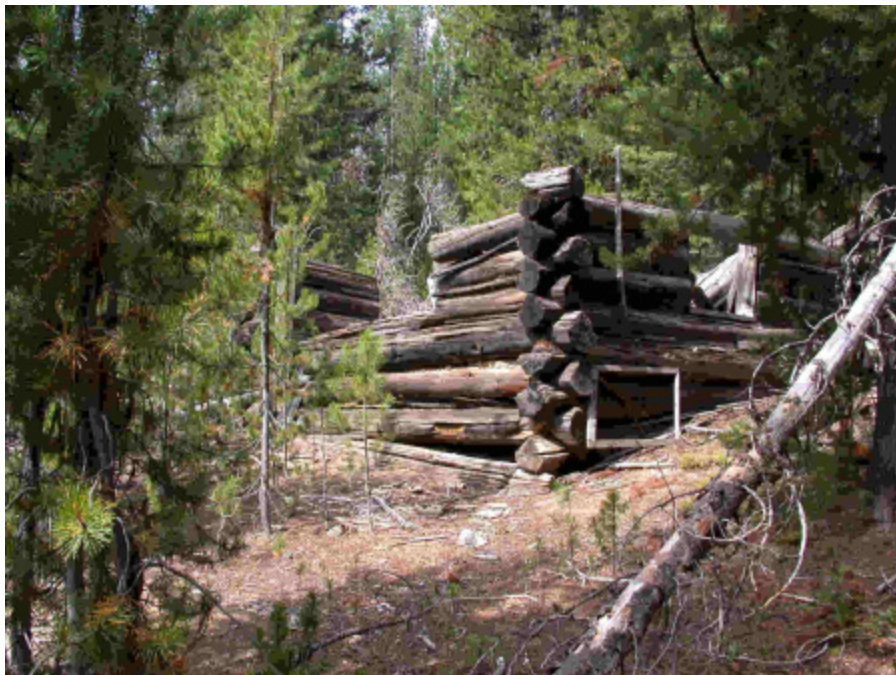
Photo 2. Log structure. (Photo by D. Boles)

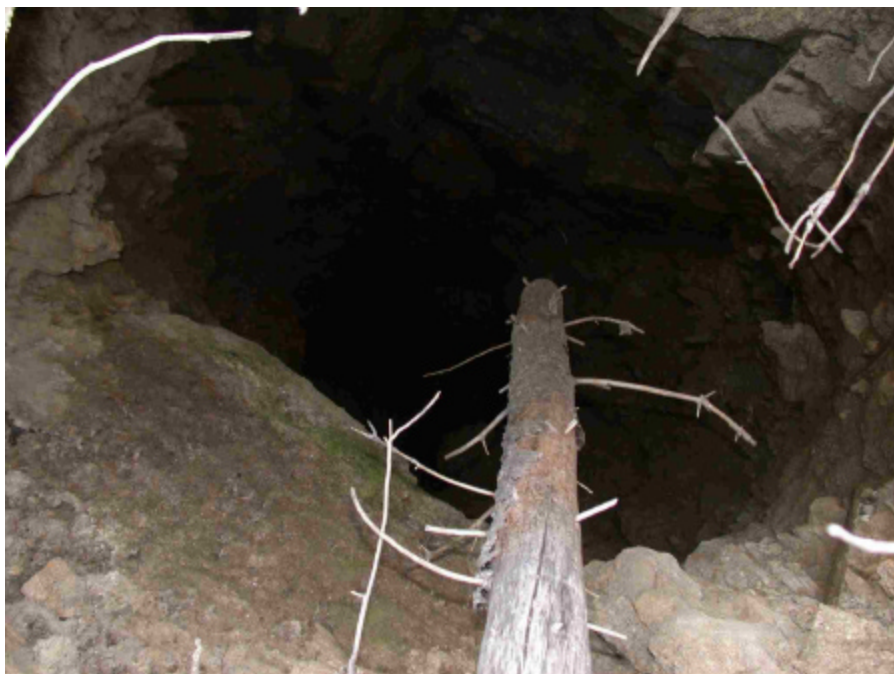
Photo 3. Inside shaft. (Photo by D. Boles)

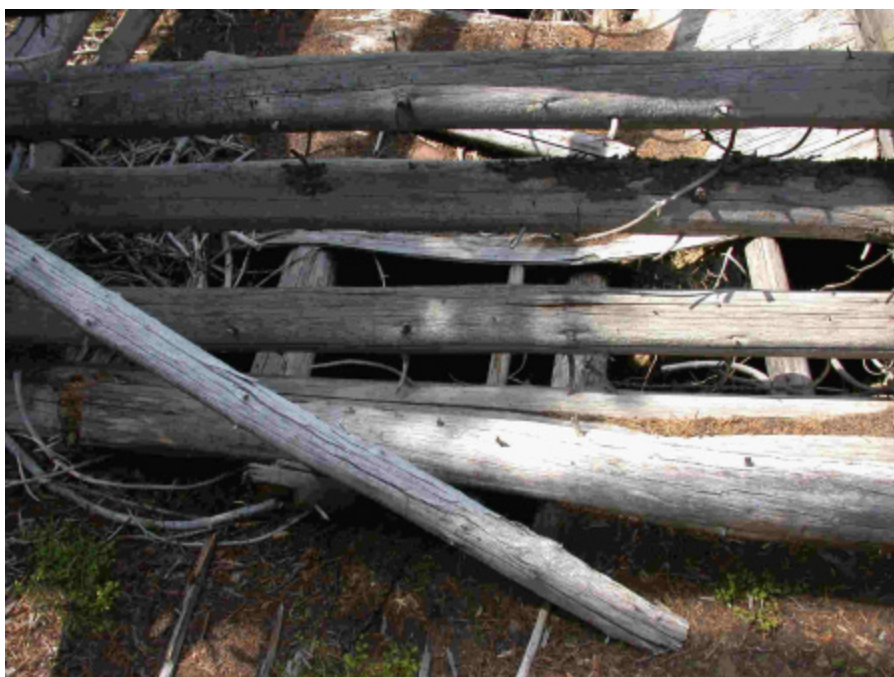
Photo 4. Log fence and old plywood covering shaft. (Photo by D. Boles)

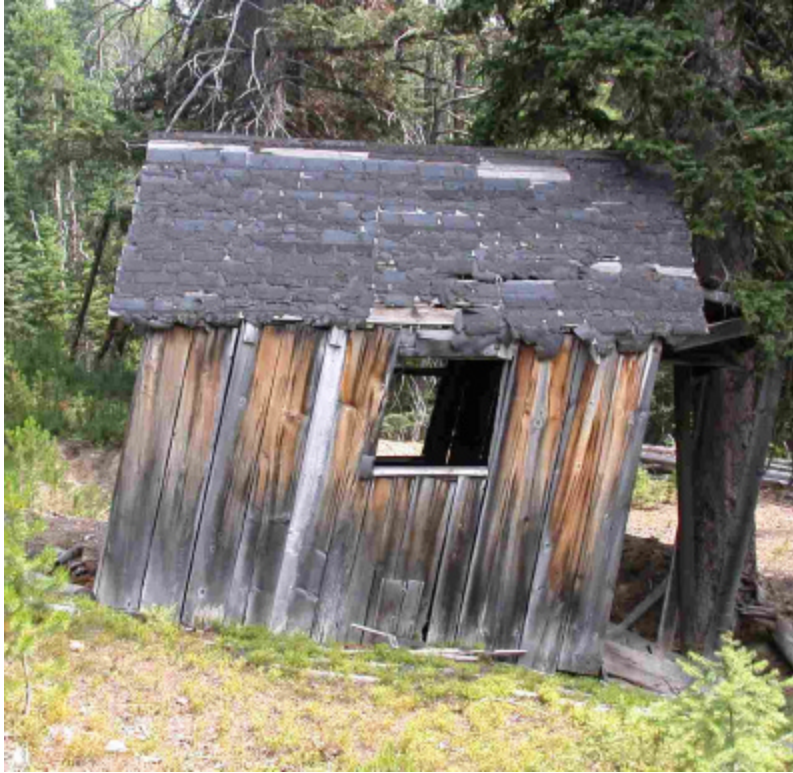
Photo 5. Office/Assay building below adit. (Photo by D. Boles)

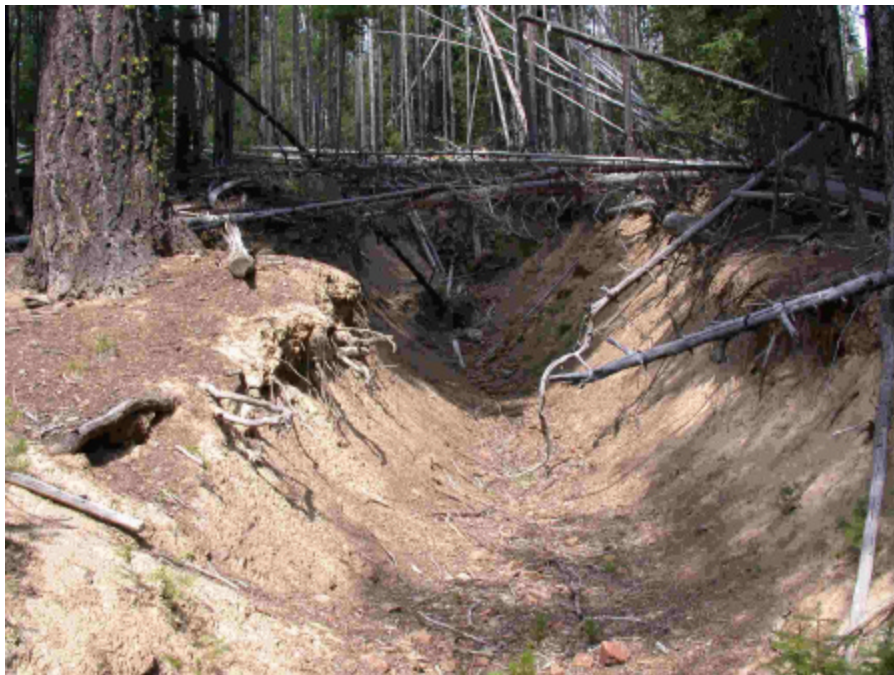
Photo 6. Adit above building in Photo 5. Partially open. (Photo by D. Boles)

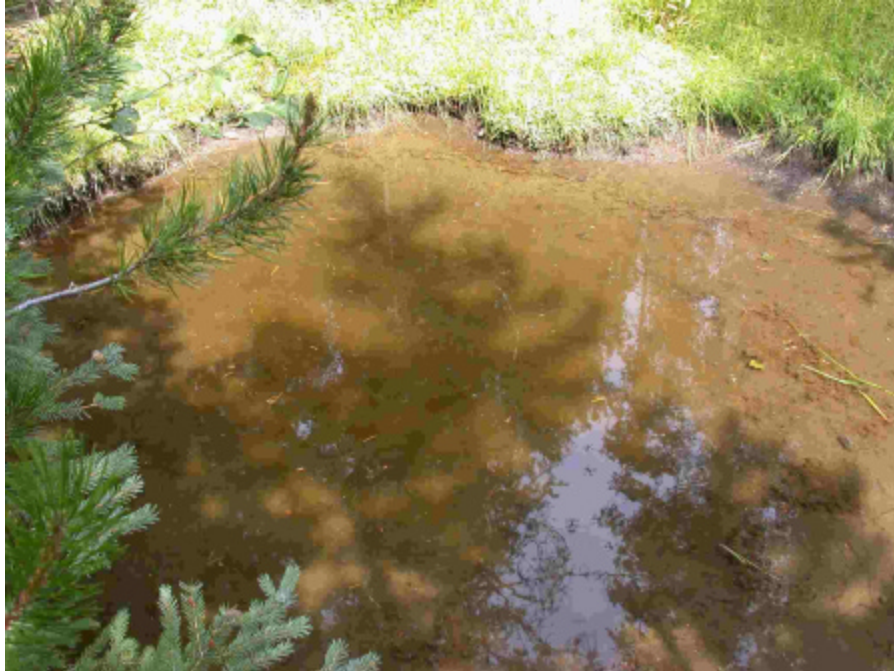
Photo 7. One of many impoundments below wasterock and other workings.
(Photo by D. Boles)

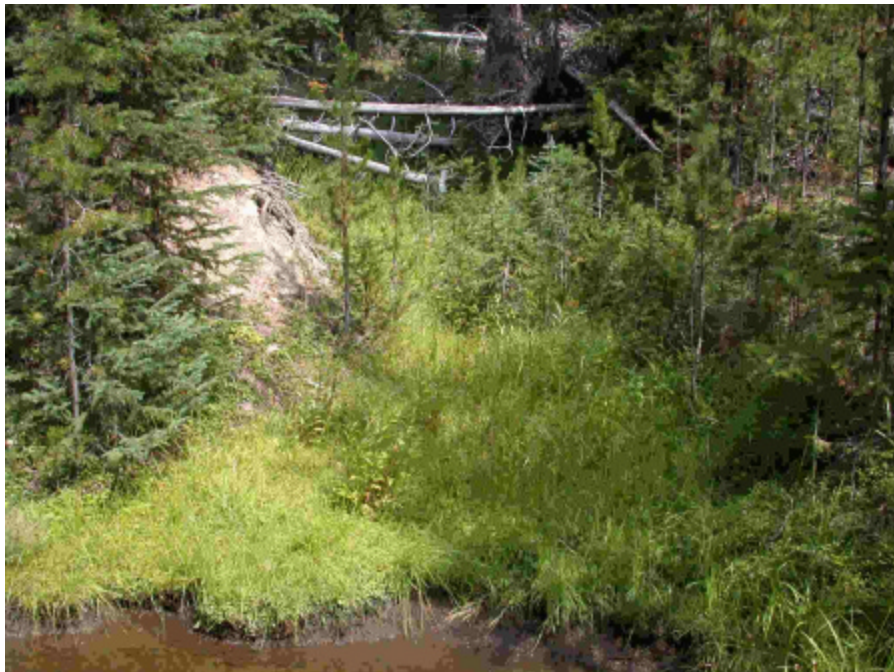
Photo 8. Unnamed tributary. Water was present throughout the drainage.
Note wasterock to the left. (Photo by D. Boles)
